Application of Vertical Electrical Sounding for Subsurface Characterization to Determine Slope Instability at Perizie, Nagaland

Abstract

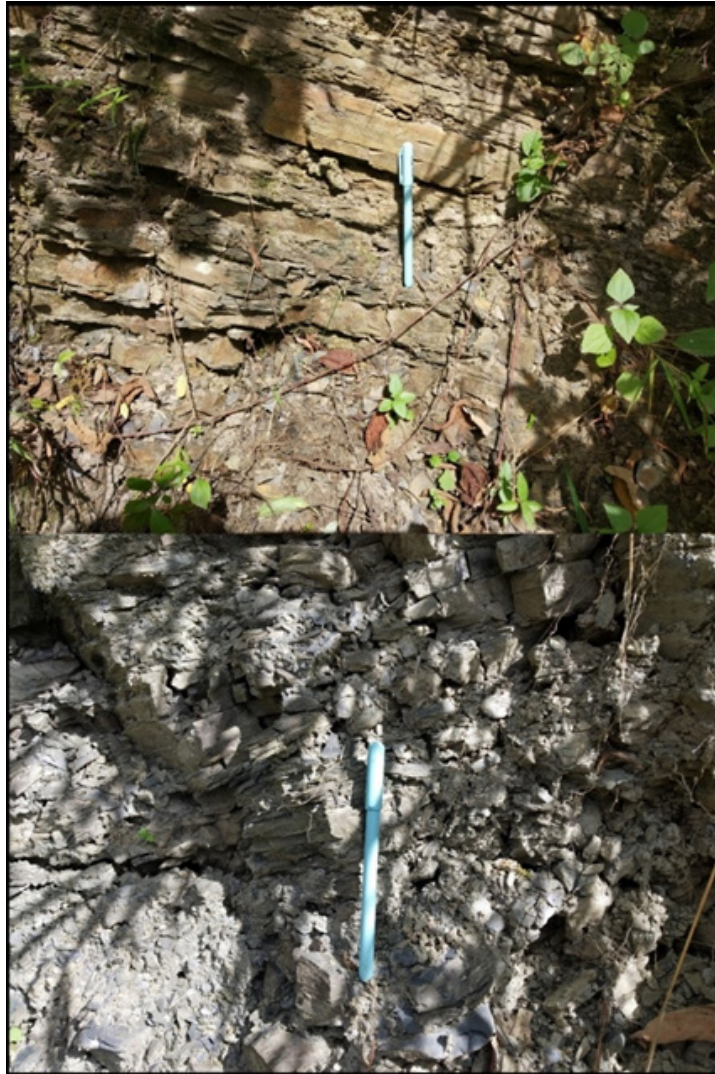
Fig. 2: Rock exposures showing fractured and weathered shales.

weathered, and fractured. Field photographs showing the exposed fractured and weathered shales are given in Fig. 2.

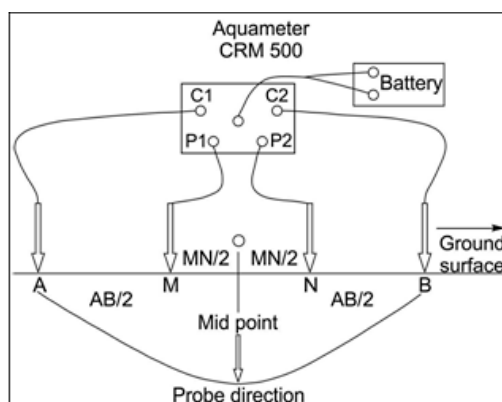
Fig. 3: Schlumberger array field method.

Here, five electrodes are used, where centre of the electrode is kept fixed and measurements are taken for various values of expanding current electrode. The two outer electrodes, the current electrode, act as the source and the other two inner electrodes, the potential electrode, serves as the receiver.

The current (I) is introduced between the current electrodes pair, say, A and B and the potential difference (δV) produced is measured with the help of the potential electrodes pair, say, M and N. All the four electrodes are stretched along a straight line, with the current electrodes spacing kept large in comparison with potential electrodes spacing (Fig. 3). The present study employs the Schlumberger configuration⁵⁵ following the spacing of the current electrode and the potential electrode by order of 5, i.e., $AB/2 \geq 5 MN/2$. This configuration gives a good resistivity contrast between the saturated and unsaturated layers for analysing the subsurface condition.

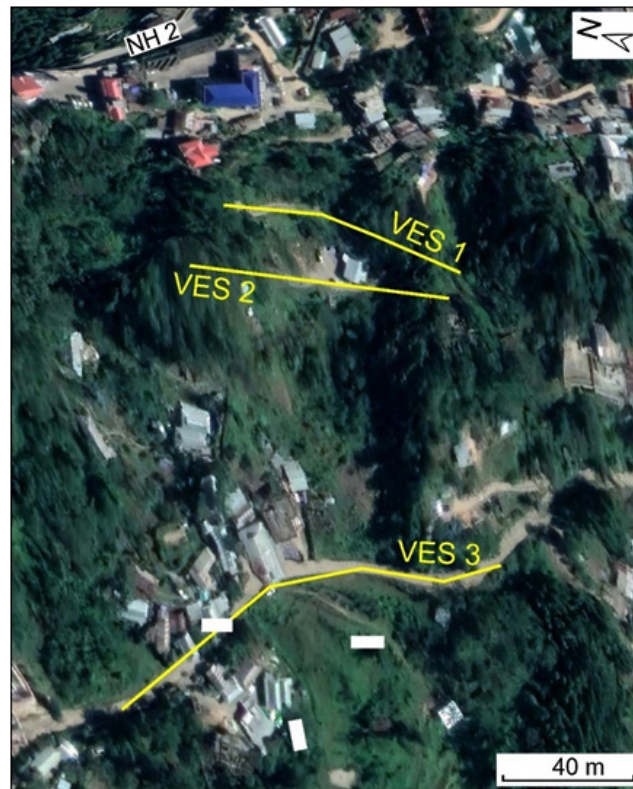
Fig. 4: Google earth image of the study area with VES stations

3 (three) VES locations were selected along the colony road to collect the field data (Fig. 4) and analysed for determining the resistivity layers.

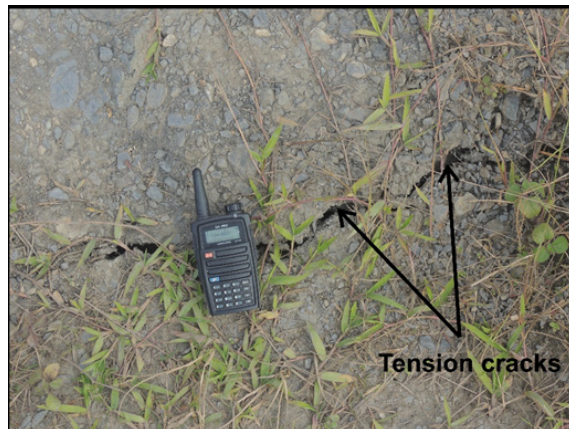
Fig. 6: Tension cracks seen at VES 3 survey location

VES 3 shows KHK curves type with resistivity values given as $\rho_1 < \rho_2 > \rho_3 < \rho_4 > \rho_5 > \rho_6$. The top soil occupies the first layer as coverage with thickness of 0.691 m and resistivity value 85.48 Ωm and a second layer containing shale is found with a resistivity value of 256.7 Ωm and a thickness of 1.095 m. Weathered to highly weathered shale or clay is found at the third and the fifth layers showing resistivity values ranging between 20.79 Ωm to 23.83 Ωm . The fourth layer with resistivity values of 76.82 Ωm with thickness 4.74 m indicates layers containing fractured shales. This layer points to the presence of groundwater (Table: 2). Development of tension cracks can be seen at the VES 3 survey location. These fissures act as the pathways for maximum water infiltration

of surface water, thereby facilitating the increase in the saturation level of the subsurface materials. This leads to increased pore water pressure and reduced shear strength of the slope material (Fig. 6).

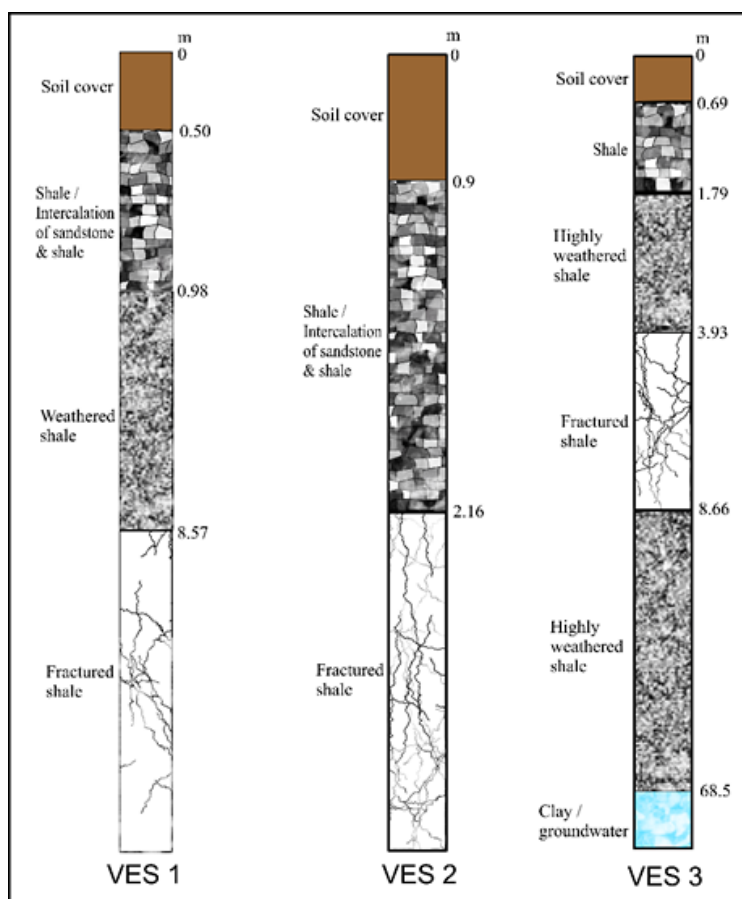
Fig. 7: Lithologic description at VES1, VES2, VES 3 survey locations

The VES results are used to construct the subsurface lithologic description diagram, which shows a good correlation with the bore-hole data (Fig. 7)

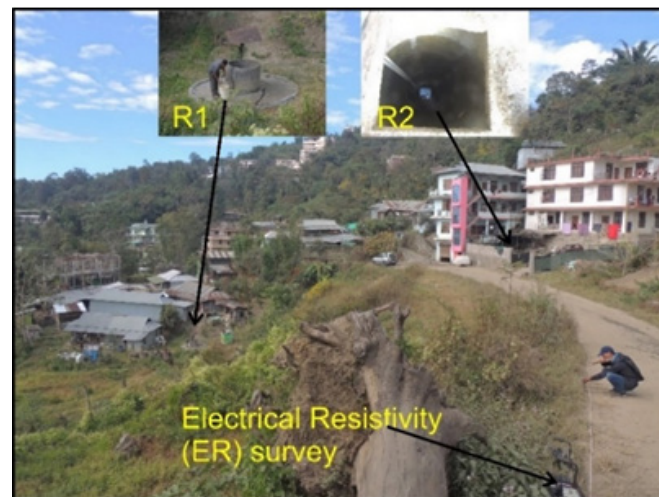
Fig. 9: Image showing the ring wells (R1, R2) and ER survey location (Date of field photos and ER survey: 28-11-2020)

During the fieldwork, three ring wells were found at different places in the vicinity of the VES survey stations. The following tabulation was made after an inquiry from the local residents (Table: 3).

The resistivity survey was taken during the month of November, which is considered a dry season, and the existence of abundant water in the three ring wells during this season indicates that the area

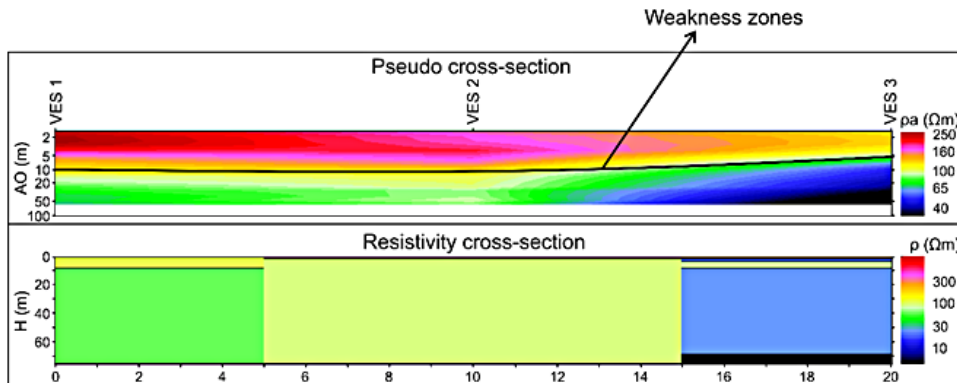
Fig. 10: Pseudo and Resistivity cross sections along VES 1, VES 2, and VES 3

The pseudo cross section obtained for the three VES locations indicates a low resistivity zone seen at VES 3, and continues towards VES 2, at a depth 30 m below the surface. A region of high resistivity zone (>250Ωm) at VES 1 indicates an area with less moisture content. Part of weakness zones consisting of soft materials between VES 1 and VES 3 is identified at a depth of about 10 m (approx.) from

the surface. This is represented by the boundary contrast between the zones with moderately high resistivity values and low resistivity values. The presence of this weak zone indicates that the probable sliding of the slope materials might have initiated from this boundary, which led to the slope failure (Fig. 10).

The pseudo cross-section helped to identify the presence of the weak zone between VES 1 and VES 3 at depths of 10 m from the surface. During the monsoon season, the surface runoff can cause surface water infiltration into the weathered rock, which can easily seep in within the weakness zones, thereby increasing the weight of the weathered materials that can initiate slope failure.
