# The Sand Bar Formation and its Impact on the Mangrove Ecosystem: A Case Study of Kadalundi Estuary of Kadalundi River Basin in Kerala, India

K B BINDU<sup>1\*</sup> and G JAYAPAL<sup>2</sup>

Department of Geography, Kannur University.

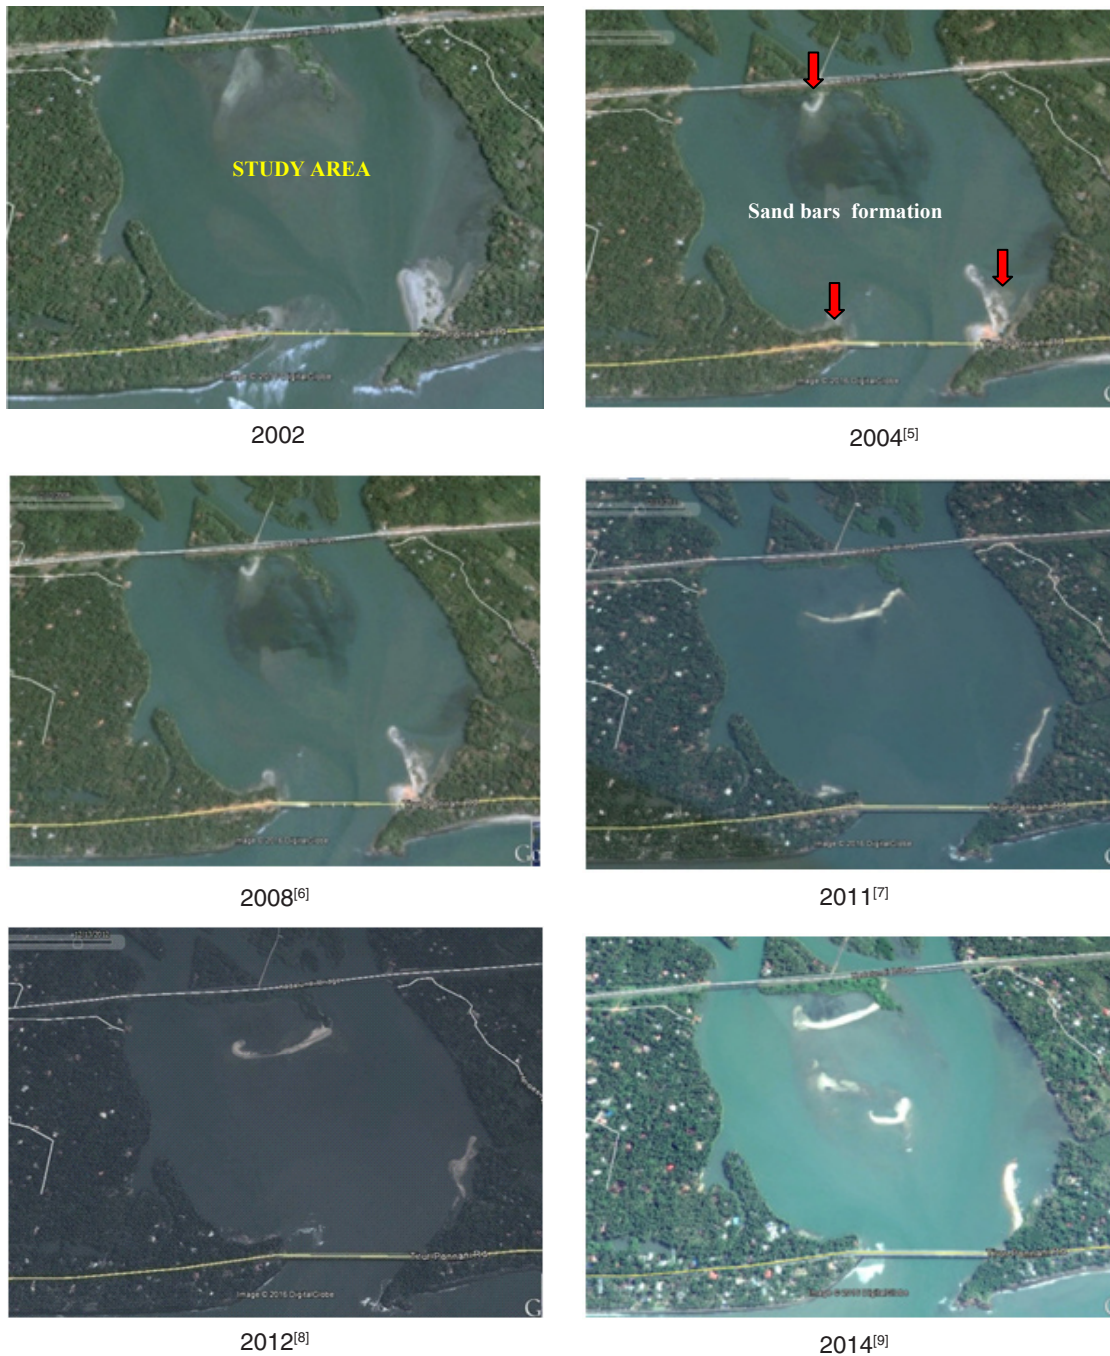
**Fig. 3: Temporal and Spatial Formation and Changes of Sand Bars from the year 2002 - 2014**

The present study reveals the morphological characteristics of sand bars formation and its movement during the period of 2002 to 2014. In the year 2004<sup>[5]</sup>, small patches of sand appeared on the outskirts of the mud flats formed near the Kadalundi railway bridge as shown by a red arrow in Figure 3. These sand bars expanded and formed like a hook shape near the mud flats as seen in the image of the year 2008<sup>[6]</sup>. In the year 2011<sup>[7]</sup>, a long stretch of the sand bar was developed which expanded and spread parallel to the mud flat under the Kadalundi railway

bridge as seen in the image of the year 2012<sup>[8]</sup>. In the image of 2014<sup>[9]</sup>, this long stretch of the sand bar is found close to the patches of mangroves on the mud flats below Kadalundi railway bridge. These series of images as shown in Figure 3 not only depicts the morphological characteristics of sand bars formed in the Kadalundi estuary but also their temporal and spatial changes occurred in the span of twelve years. The image reveals that the sand bars are moving and are not permanent in a place. Figure 4 shows that approximately 56 meters of the sand bar was found shifted towards the terrestrial mangrove area. The formation of new sand bars of 1332 sq. km was found near the mouth of the estuary.

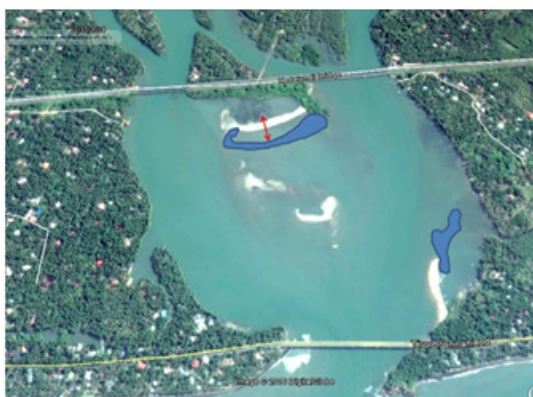
**Fig. 4: Shift of Sand Bars from the year 2013 to 2014**

bar may be many but still more study is to be done in this regard. The washed away sand from the salt water intrusion bund on the upper streams of the kadalundi river near to the kadalundi estuary gets accumulated in this area. This may be due to lack of proper flow of water from the kadalundi river to the sea. Due to the construction of the Tirur Ponnani road at the opening of estuary the flow from sea to the river side is obstructed and due to low flow, the sand particles carried by the waves are deposited as sand bars. Construction of boat jetties near the mouth of the estuaries also block the sand sediments from being washed away. Hence, if this condition prevails, both these natural and anthropogenic activities will lead to complete elimination of mangrove vegetation from Kadalundi-Vallikkunnu mangrove ecosystem in future.

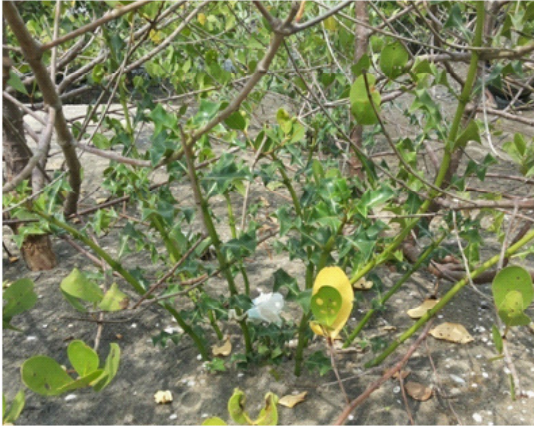
Fig 5 (a)

Among these listed mangrove species the *Acanthus ilicifolius* (Linn.) Figure 5 (a) and *Avicennia marina* (Forsk.) Vierh. Figure 5 (b) are marked as endangered species. The *Avicennia marina* is completely disappeared from the study area. The accumulation of sand near the breathing root of mangroves fills the breathing holes and result in its deterioration. The seed and seedlings of the plant were found settled on the sand bars without getting flooded away by the tidal currents.

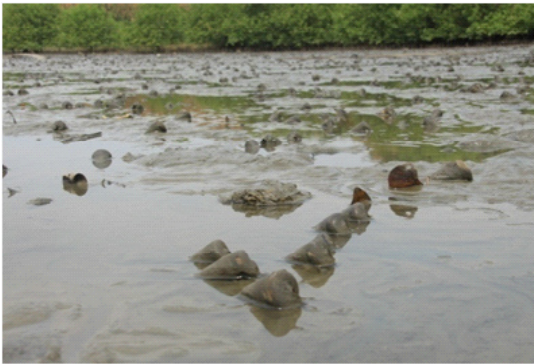
Fig 5 (e)

survive. Due to mass dieback of mangroves many fauna including small fish, sea sells, crabs as shown in Figure 5 (e) are losing their habitat as they can only survive under this mangrove ecosystem. The plastic wastes settled along the sand bars and near

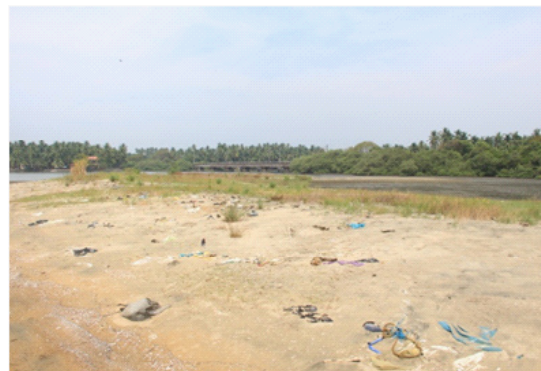
Fig 5 (f)

the roots of mangroves are causing land and water pollution, disturbing the associated flora and fauna. The Figure 5 (f) shows the plastic wastes dumped by the river water as it flows along the sand bars during low tide. The reasons for the formation of the sand
